**ILZRO RESEARCH PROGRAM ZC-26**  
Performance of galvanized steel coupons & nails in  
contact with preservative treated wood

*Prepared by*  
**NAHB Research Center**  
400 Prince Georges Boulevard  
Upper Marlboro, MD 20774-8731  
[www.nahbrc.org](http://www.nahbrc.org)

**REVIEW DRAFT**

May 2009

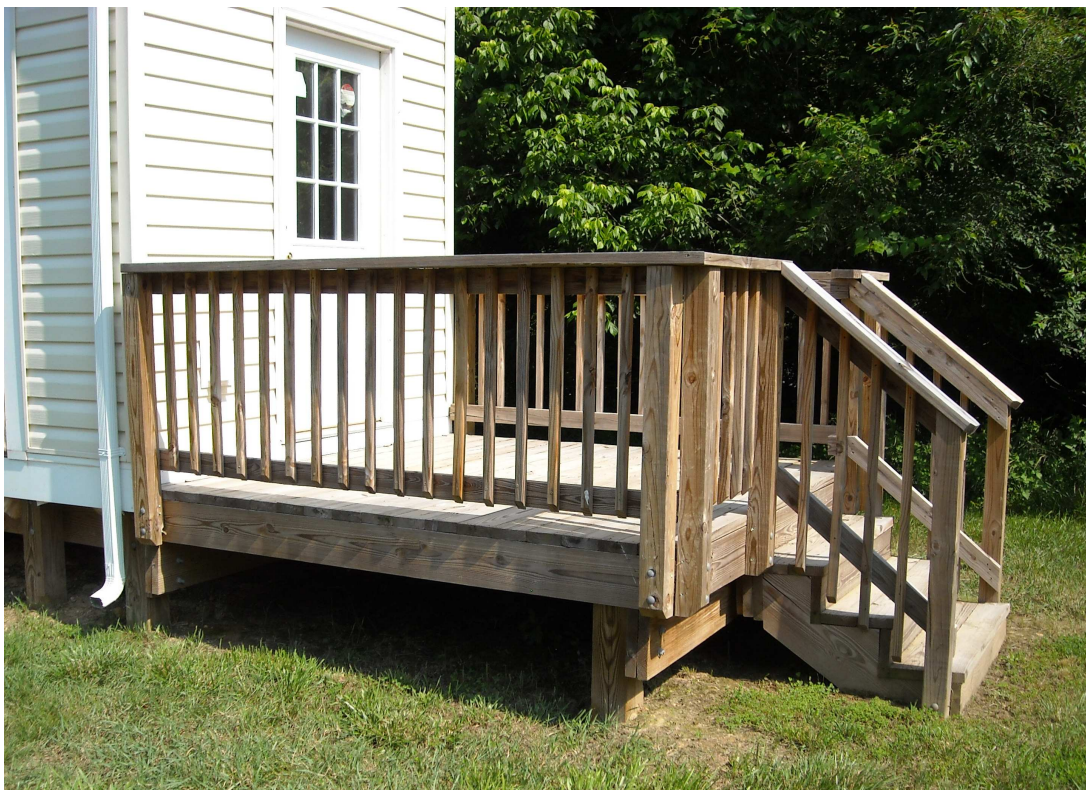
Figure 1 – Test deck

All twelve sets of specimens were installed in April of 2008. Figure 1 provides a photo of the test deck. The deck is approximately 3 feet off of the ground and constructed with 2x8 joists spaced at 24 inches on center and 2x6 deck boards attached to each joist with two wood screws. There is a 1/16 inch gap between each deck board.

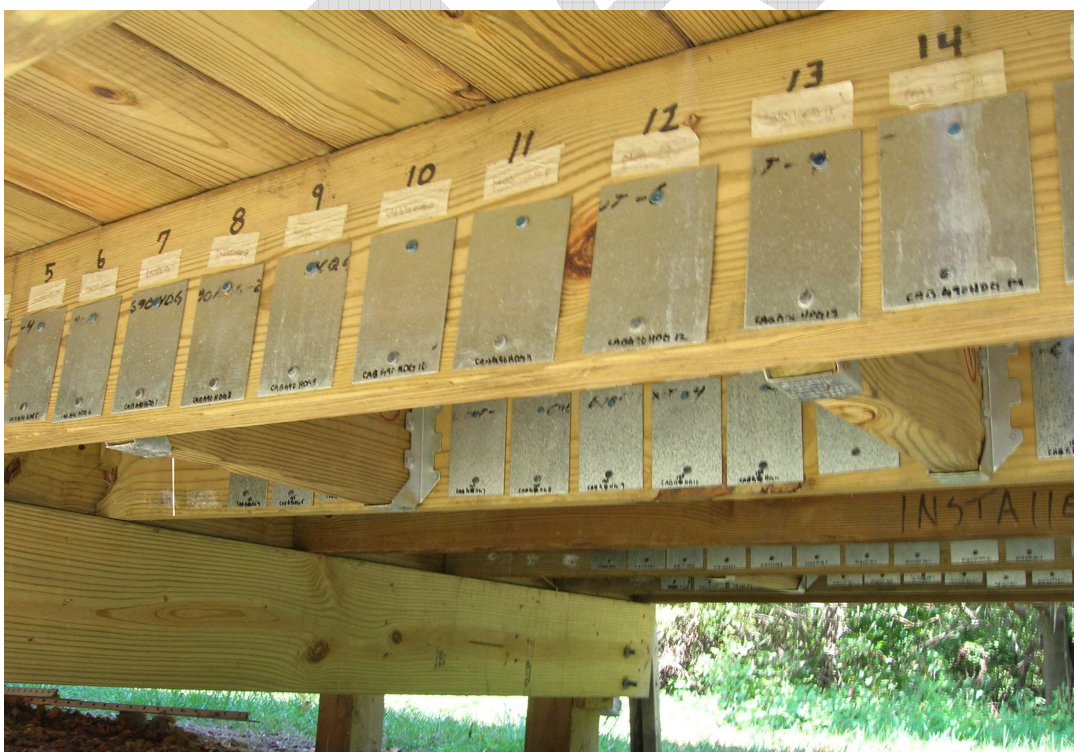
Figure 2 – Installed specimens

Specimens were installed on the faces of the deck joists, spaced at approximately 4 inches on center. The joists were pre-drilled using a 1/8-inch diameter drill bit. This diameter is slightly smaller than the fastener diameter and allowed the specimens to be installed and removed with the least amount of damage. The nails were installed using a rubber headed mallet and driven until the entire face of the coupon was in contact with the joist. Figure 2 provides a photo of the installed specimens.

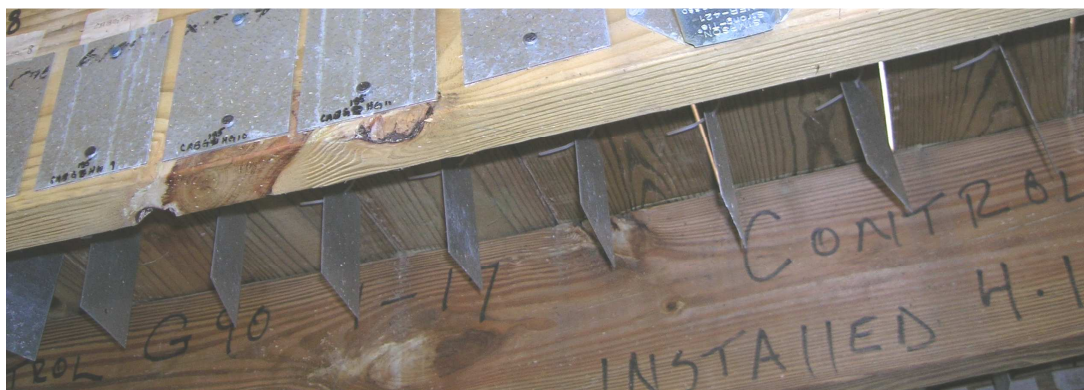
Figure 3 – Installed controls

Two sets of control specimens not in contact with preservative treated wood were also tested. The first set of controls was hung underneath the test deck between the deck joists (see Figure 3) and was exposed to the same environmental conditions as the specimens attached directly to the joists. The second set of controls was located in an interior environment with an average temperature of 72 °F and 55% relative humidity.

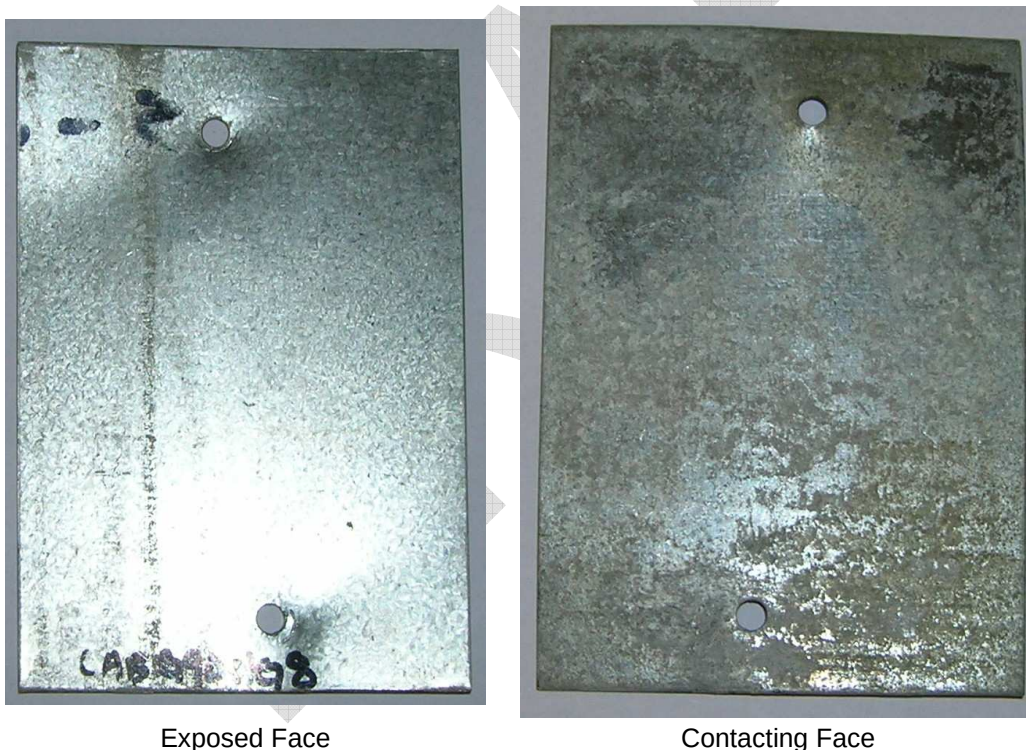
**Figure 13 – Corrosion of exposed and contacting faces of a typical coupon specimen**

In all specimens and over all exposure periods, the face of the specimen in direct contact with the pressure treated lumber exhibited far greater corrosion and corrosion product that the exposed face of the specimen (See Figure 13).

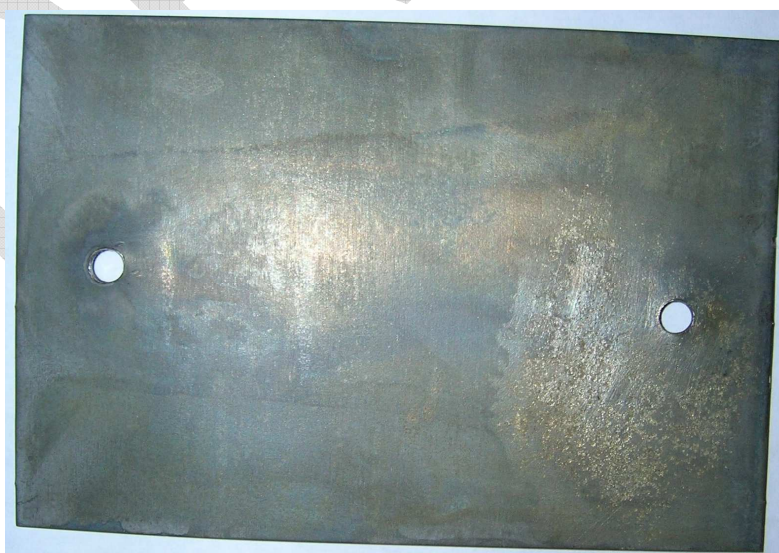
**Figure 15 – Pitting of G90 specimen (zinc coating removed) after 12 months of exposure**

For specimens coated with the G185 galvanized coating, the localized corrosion was minimal. For approximately half of the G90 coated specimens the localized corrosion was more pronounced with several specimens from both the 6-month and 12-month exposure periods showing complete removal of the galvanized coating, but only very minor pitting of the base metal. The most severe case of pitting occurred in a G90 specimen that was attached to ACQ-D wood with hot dipped galvanized nails (Figure 15).

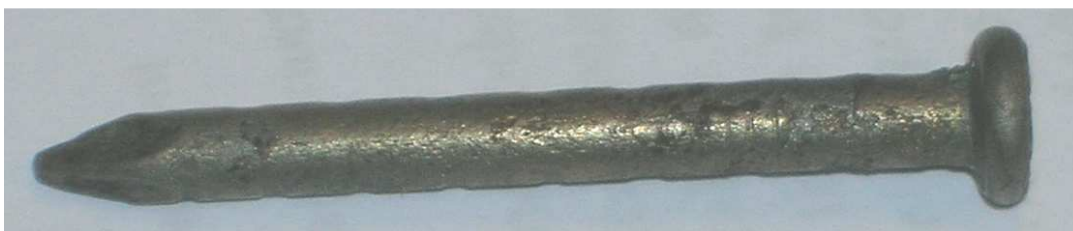
**Figure 17 – Pitting of hot galvanized nail (zinc coating removed) after 12 months of exposure**

After removal of the zinc coating, the hot dipped galvanized nails showed little to no damage of the base metal. The hot galvanized nails, however, showed some minor pitting of the base metal after 12 months of exposure and removal of the zinc coating. Figure 17 shows the most severe example of pitting on a hot galvanized nail (nail had attached a G90 coupon to ACQ-D wood).
